RÍO PUERTO NUEVO
COMPENSATORY WETLAND
MITIGATION PROJECT
THIRD QUARTERLY REPORT

April 21, 2015

- 1. Project Name:** Río Puerto Nuevo Compensatory Wetland Mitigation Project
Federal Agency: U. S. Army Corps of Engineers (USACE)
Local Sponsor: Puerto Rico Department of Natural and Environmental Resources

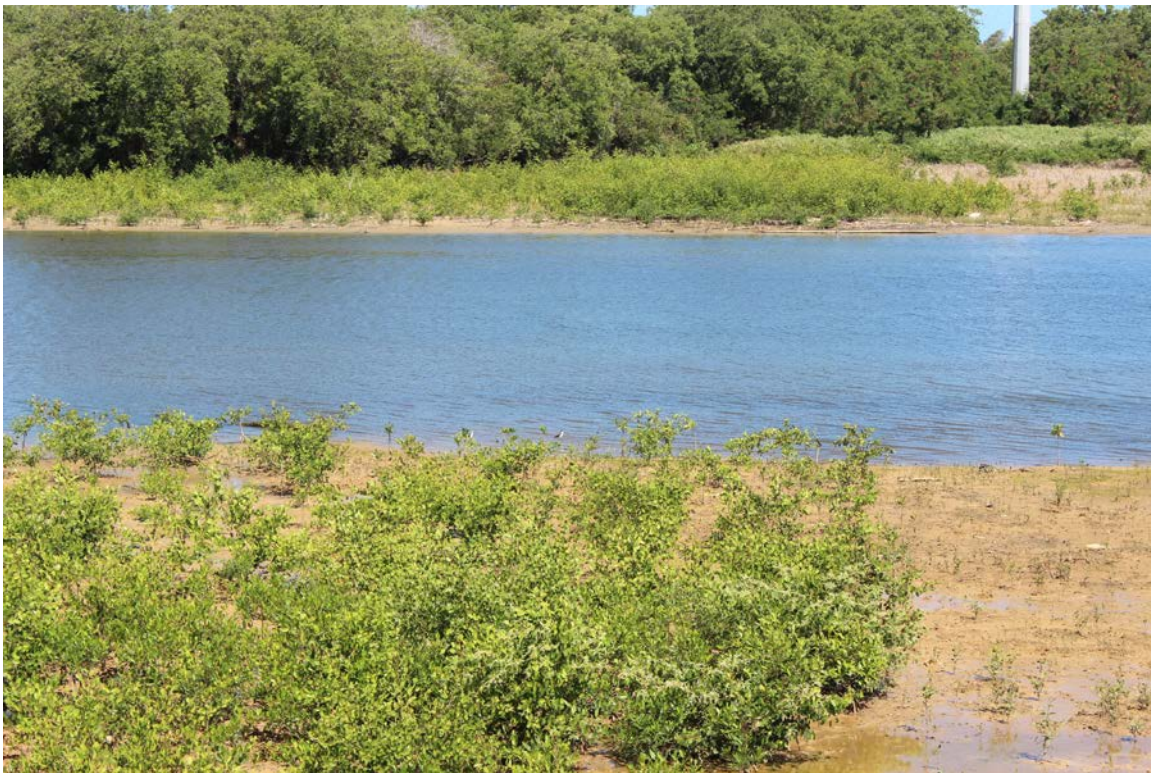
Figure 2. View of both sides of the planting terraces showing PREPA right of way with some recruitment.

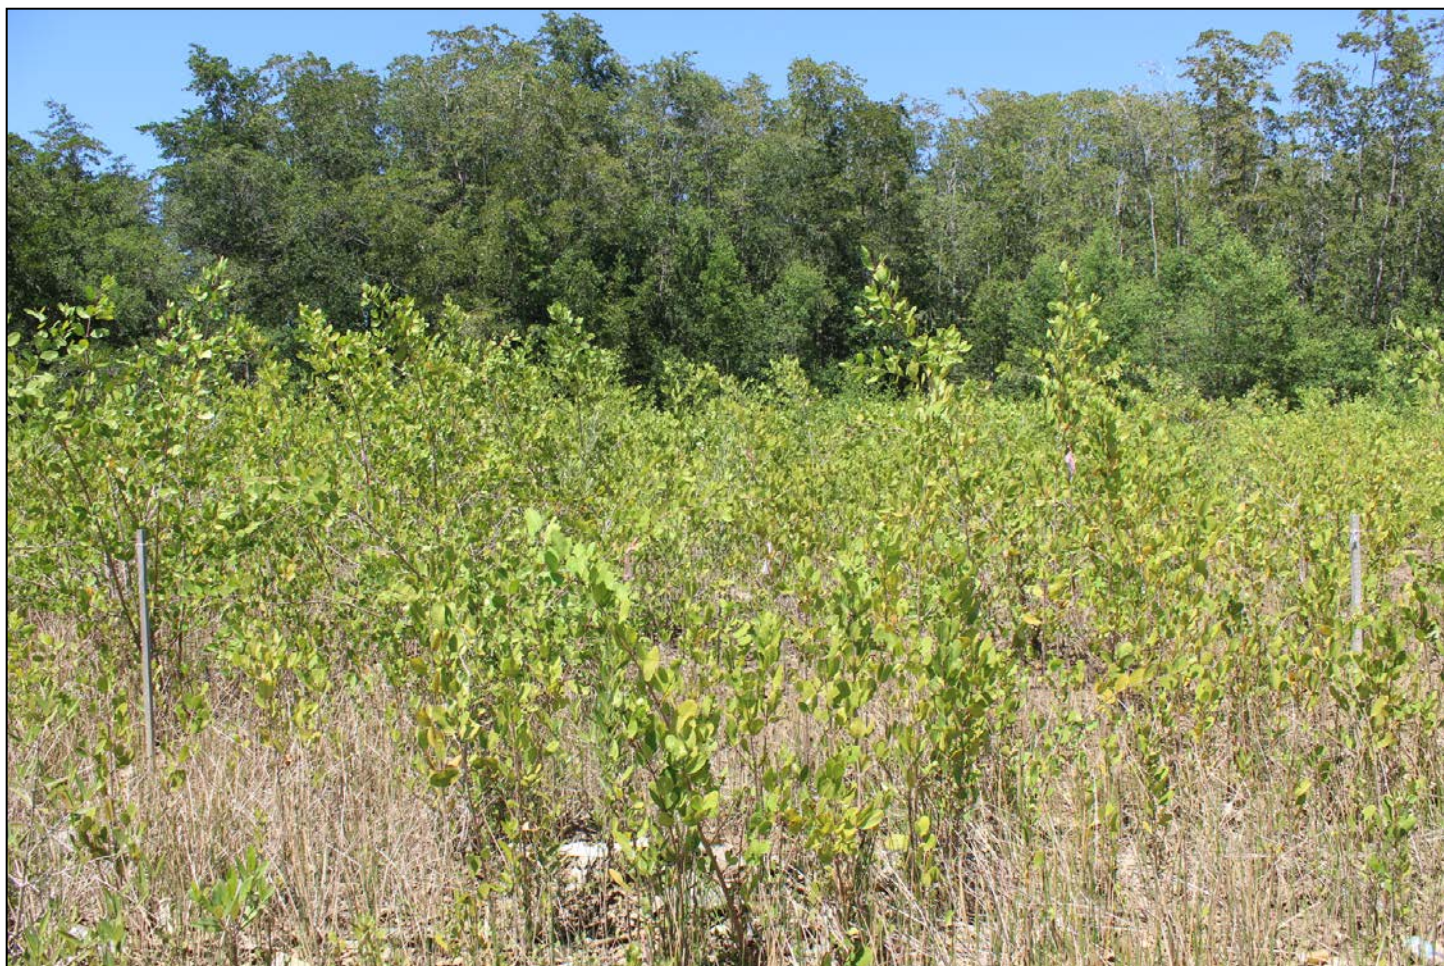
Photo sampling point #1 (Date taken: April 16, 2015)

Location: Plot #1-North side of channel

Orientation: East

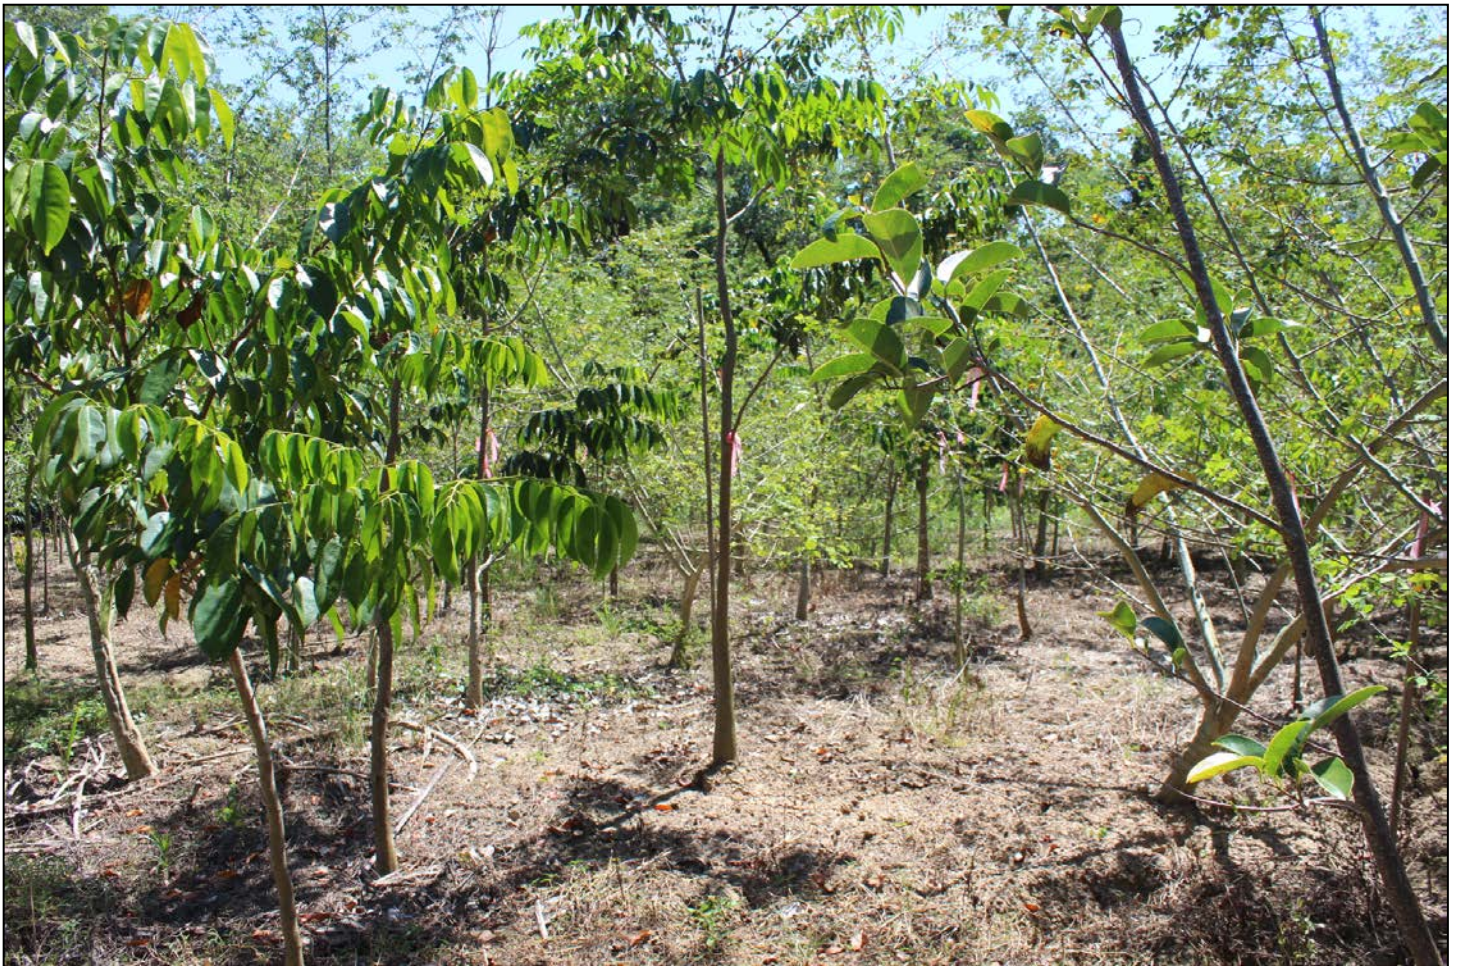
Photo sampling point #2 (Date taken: April 16, 2015)
Location: Plot #2-North side of channel
GPS coordinates: 18°25'21.41 ° N, 66.5'3.27° W (NAD 83)
Orientation: Southwest

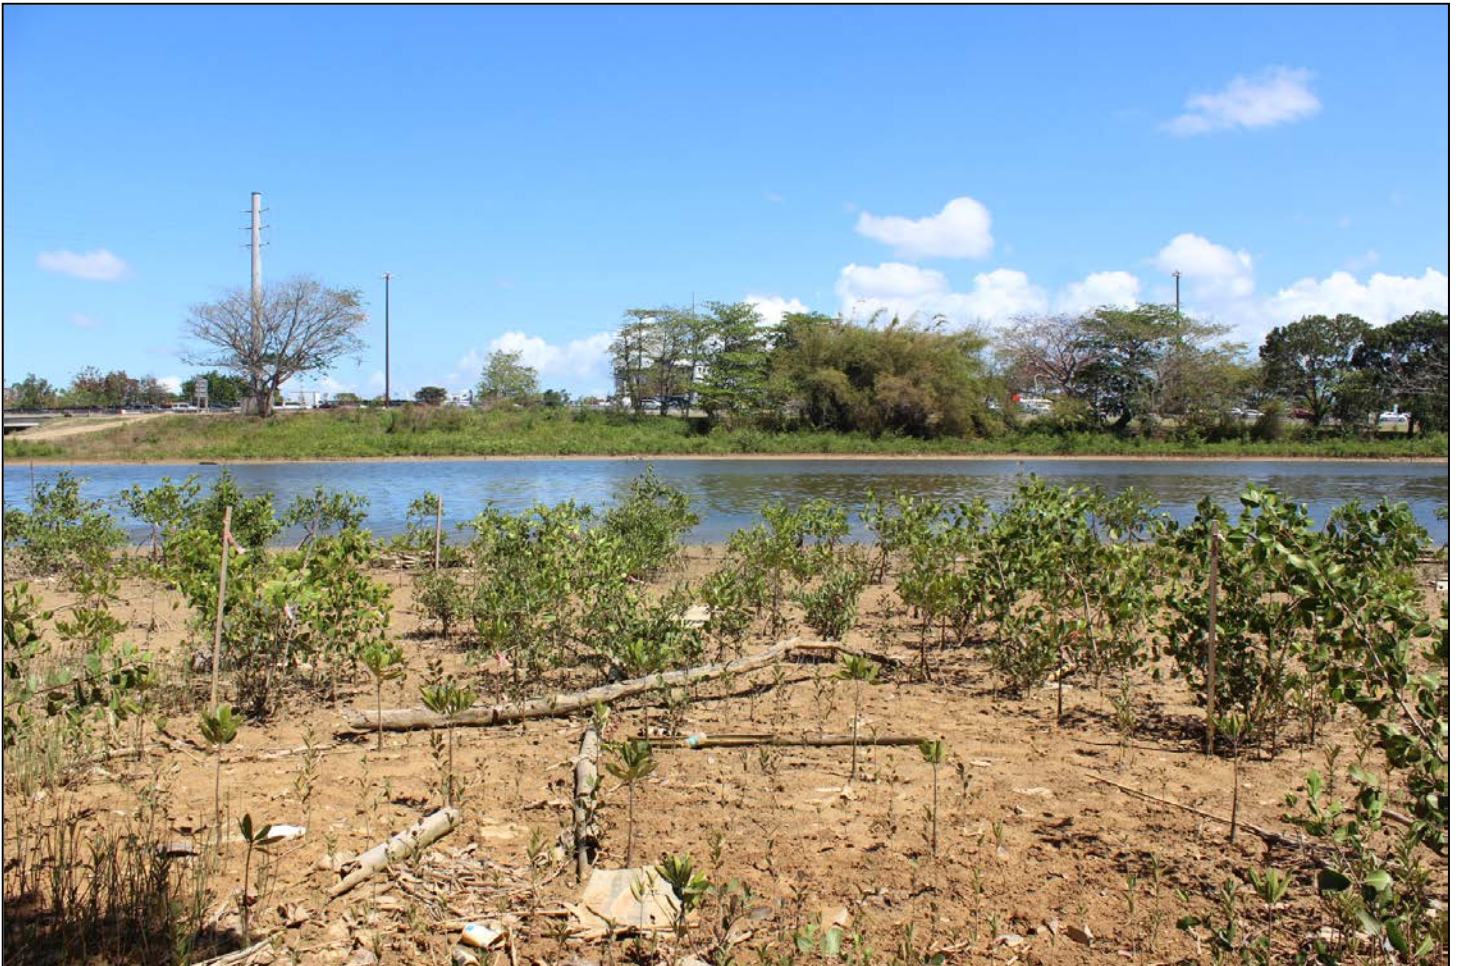
Photo sampling point #3 (Date taken: April 16, 2015)
Location: Plot #3-North side of channel
GPS coordinates: 18°25'20.17 ° N, 66.5'1.97° W (NAD 83)
Orientation: South

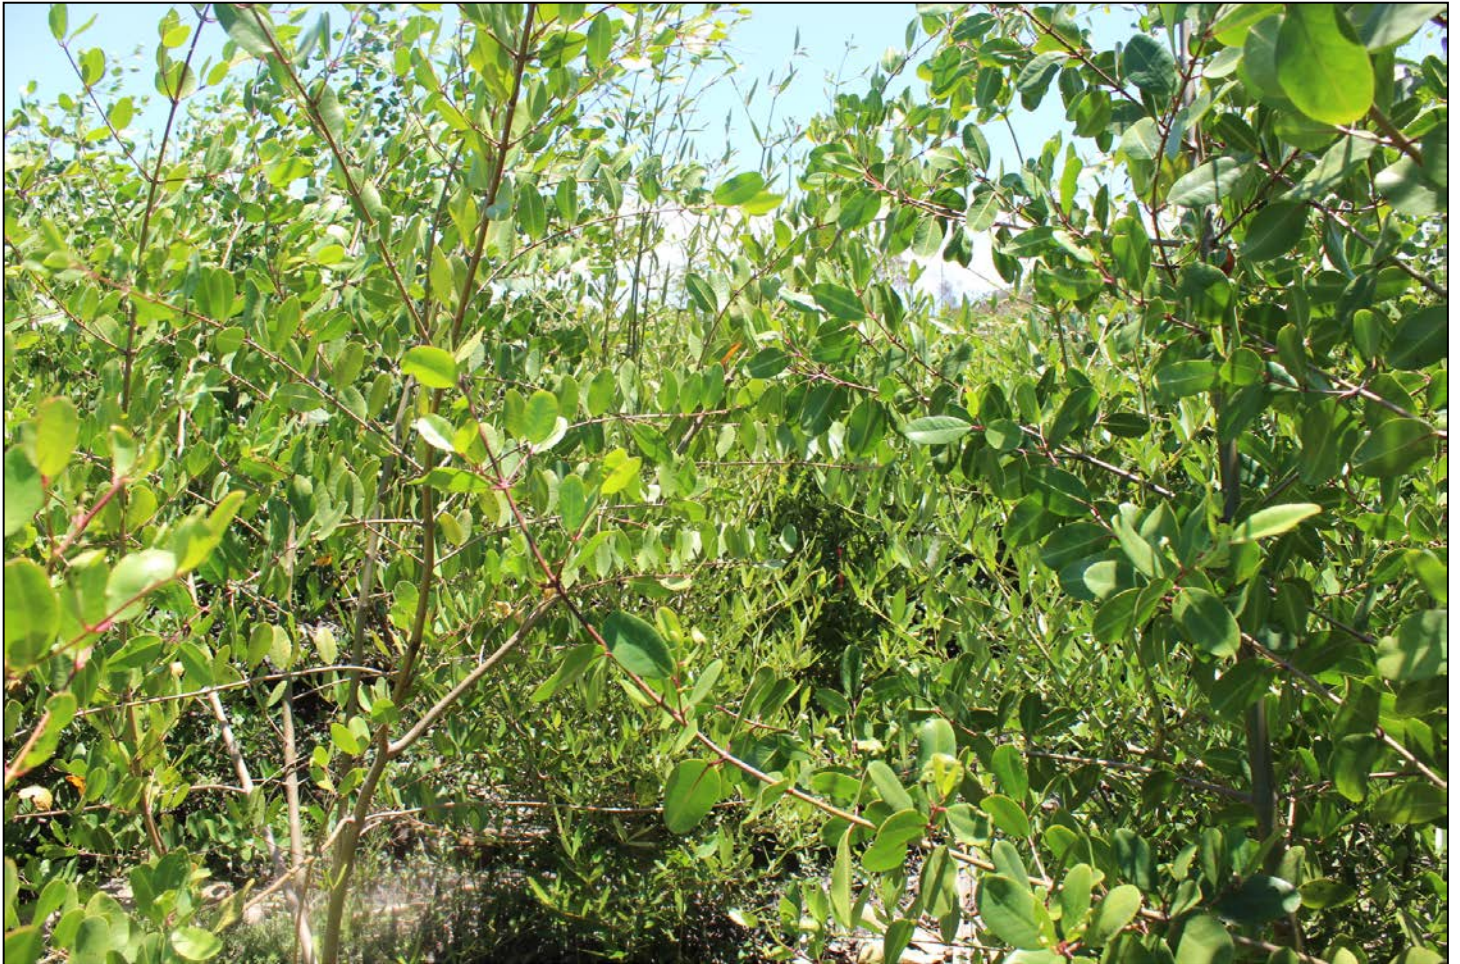
Photo sampling point #4 (Date taken: April 16, 2015)
Location: Plot #4-North side of channel
GPS coordinates: 18°25'10.88 ° N, 66.5'26.79° W (NAD 83)
Orientation: South

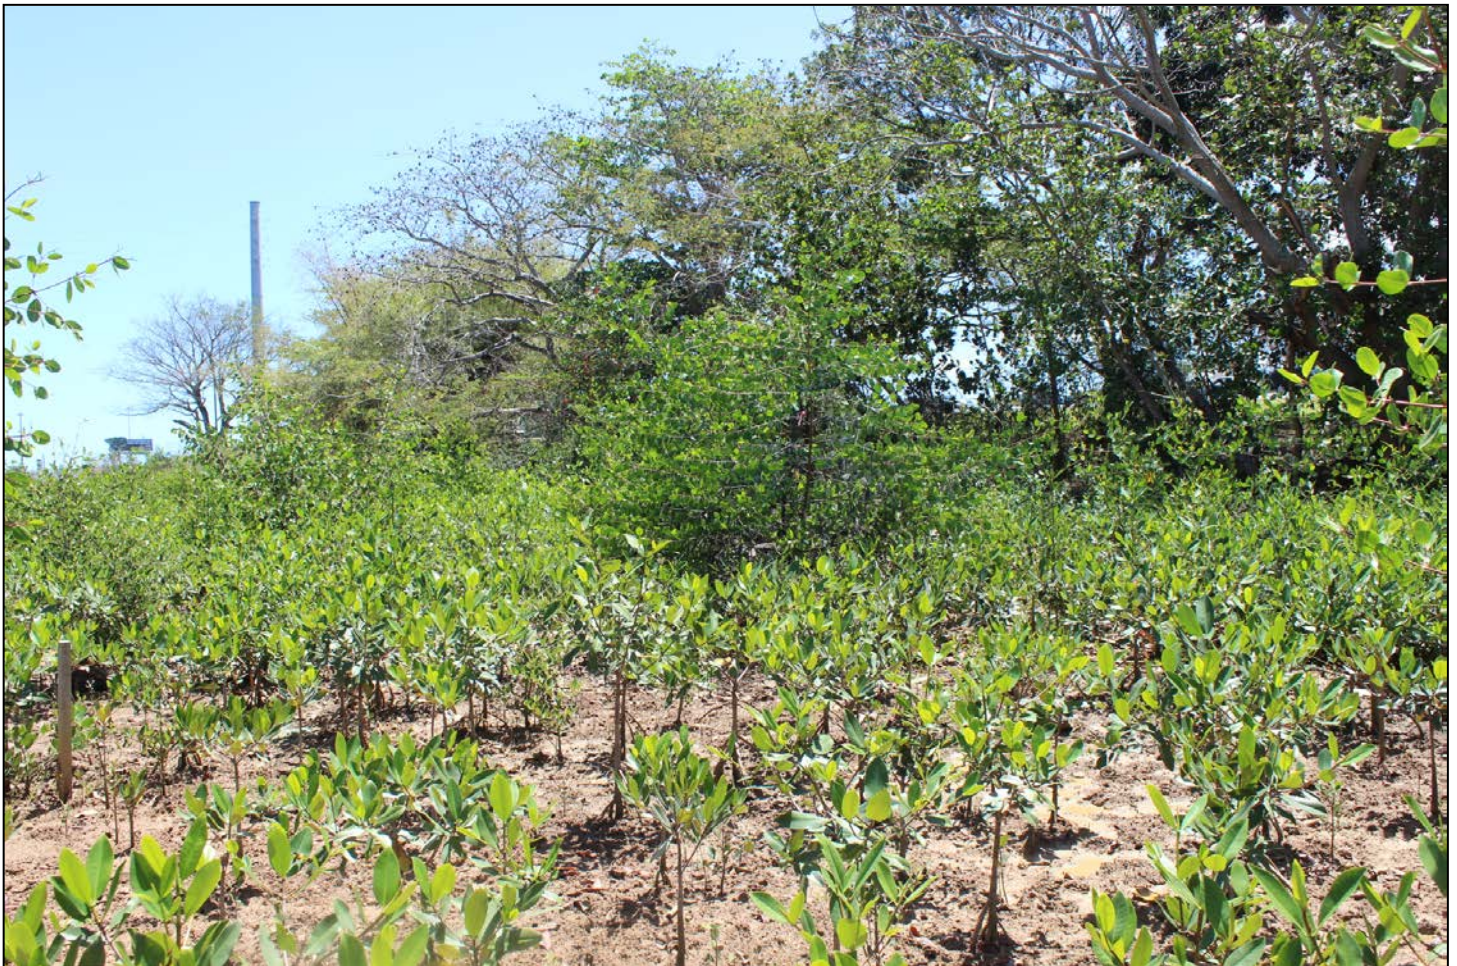
Photo sampling point #5 (Date taken: April 16, 2015)
Location: Plot #5-South side of channel
GPS coordinates: 18°25'15.88 ° N, 66.5°1.52° W (NAD 83)
Orientation: Southeast

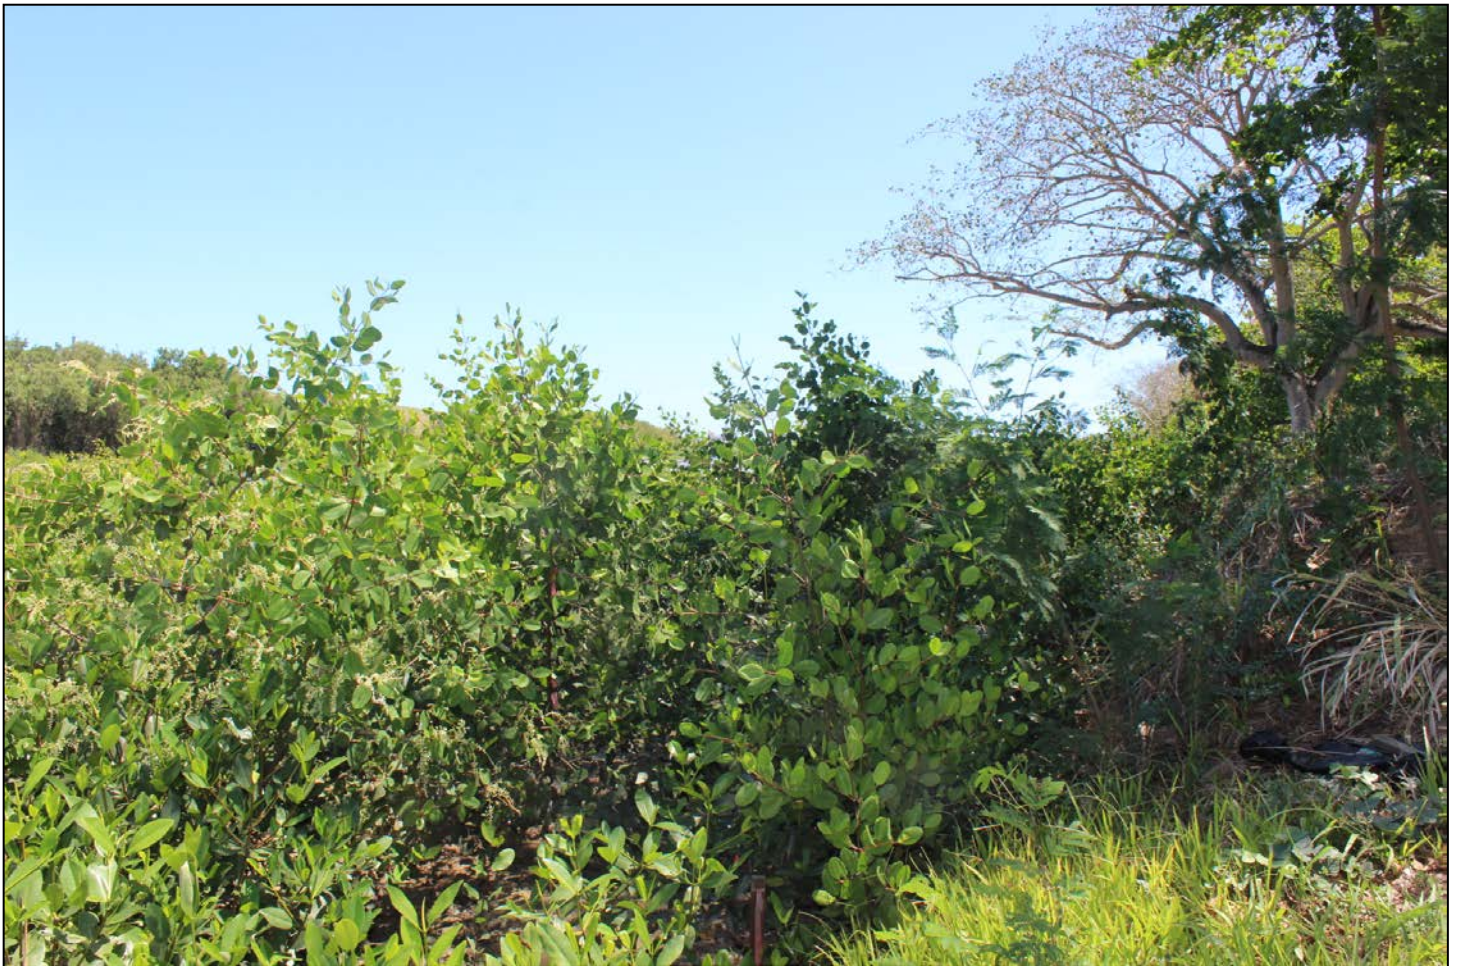
Photo sampling point #6 (Date taken: April 16, 2015)
Location: Plot #6-South side of channel
GPS coordinates: 18°25'13.62 ° N, 66.5'4.69° W (NAD 83)
Orientation: Northeast

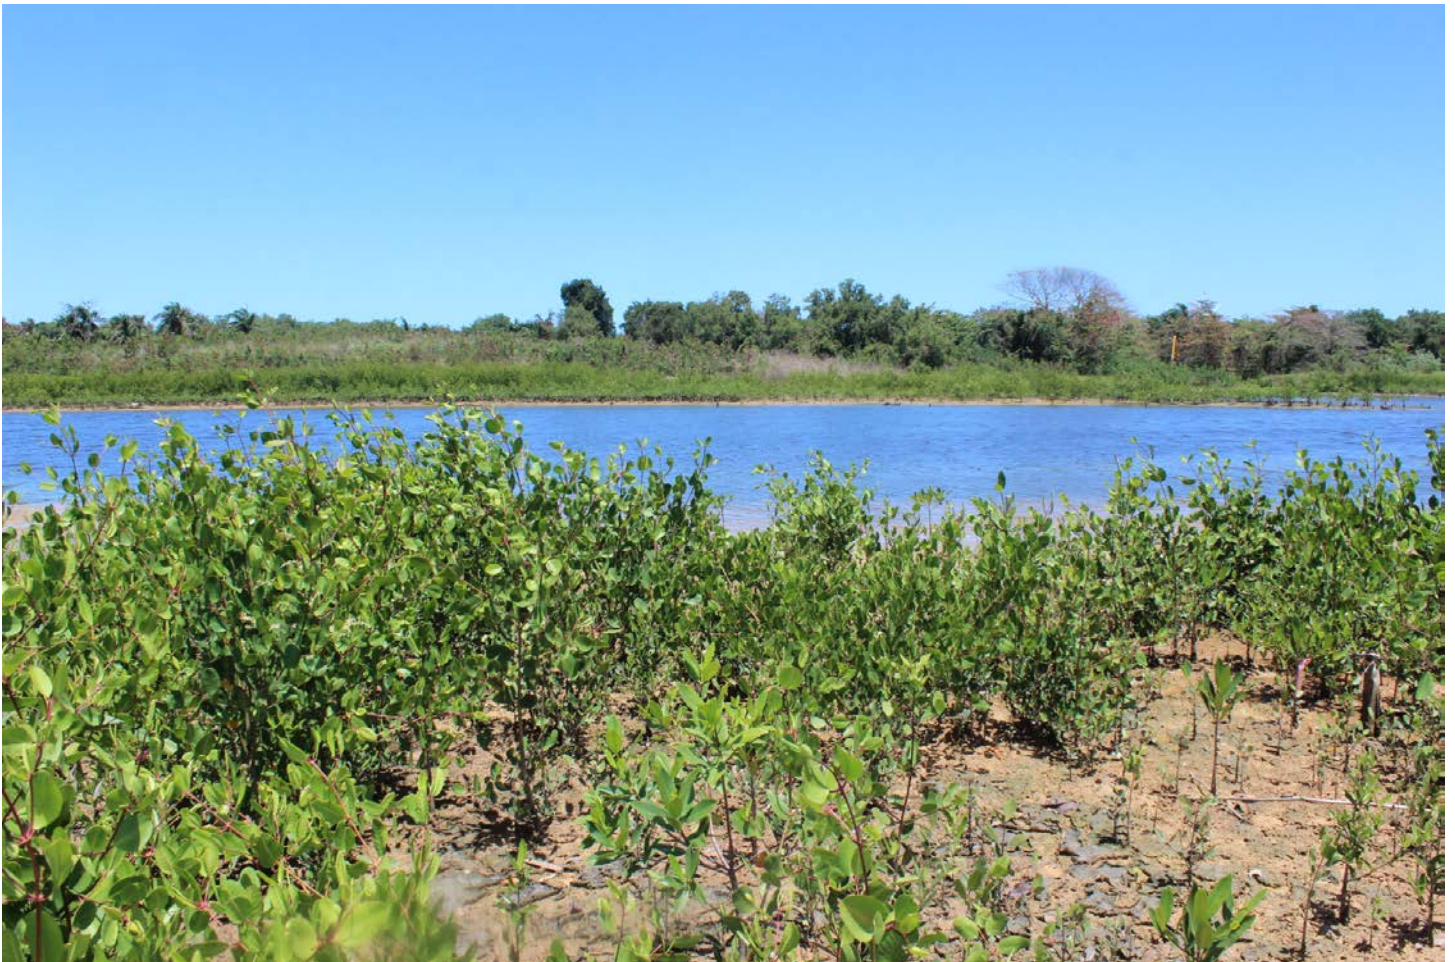
Photo sampling point #7 (Date taken: April 16, 2015)
Location: Plot #7-South side of channel
GPS coordinates: 18°25'11.52 ° N, 66.5'10.35° W (NAD 83)
Orientation: North

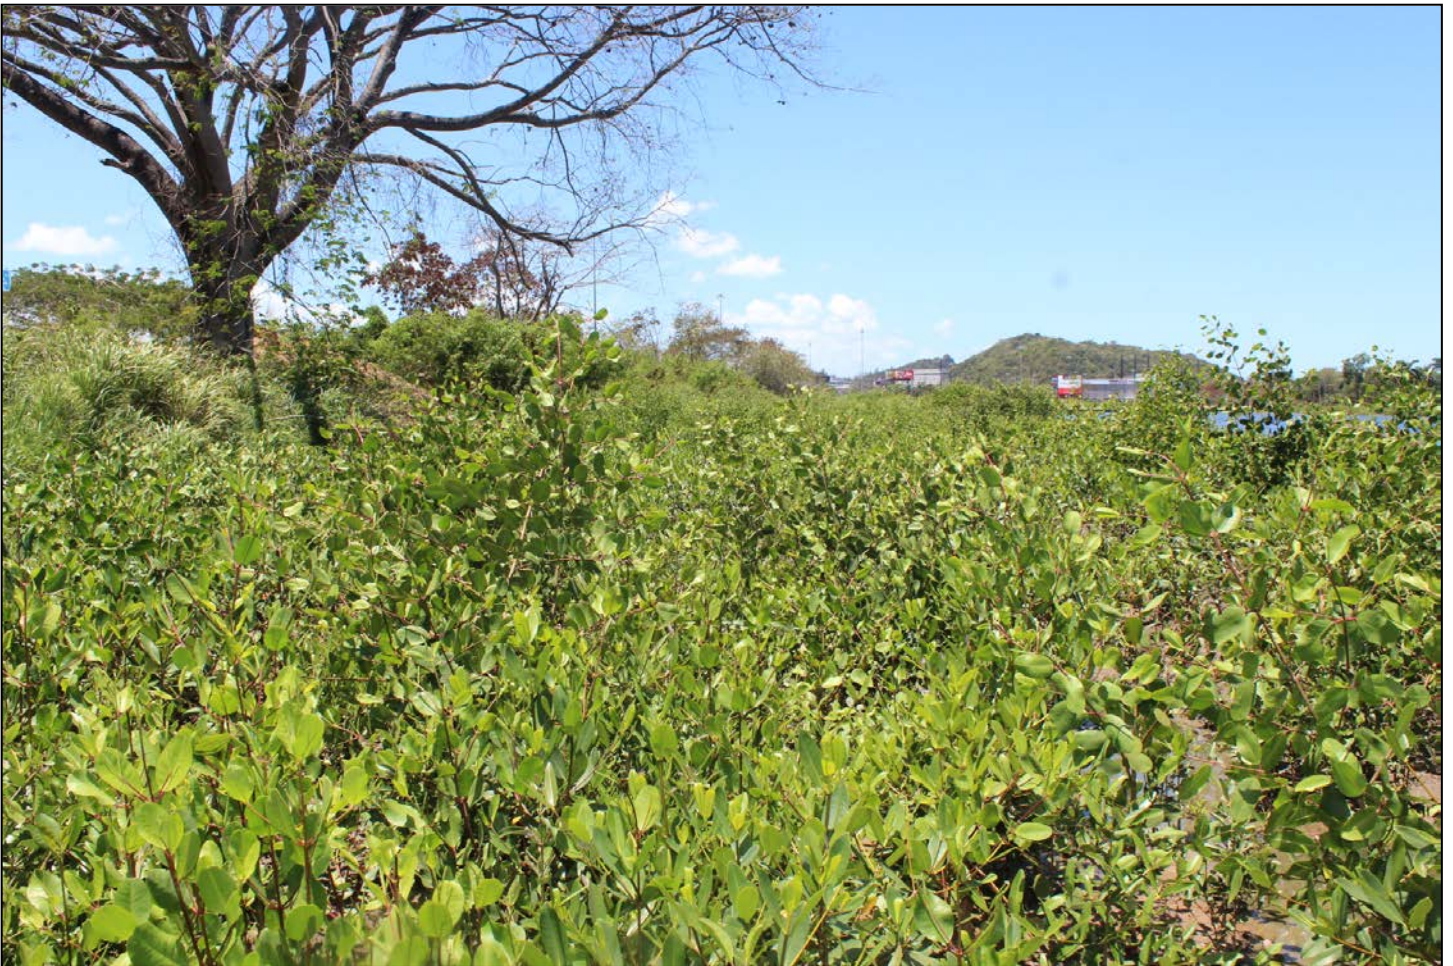
Photo sampling point #8 (Date taken: April 16, 2015)
Location: Plot #8-South side of channel
GPS coordinates: 18°25'8.18 ° N, 66.5'20.11° W (NAD 83)
Orientation: West

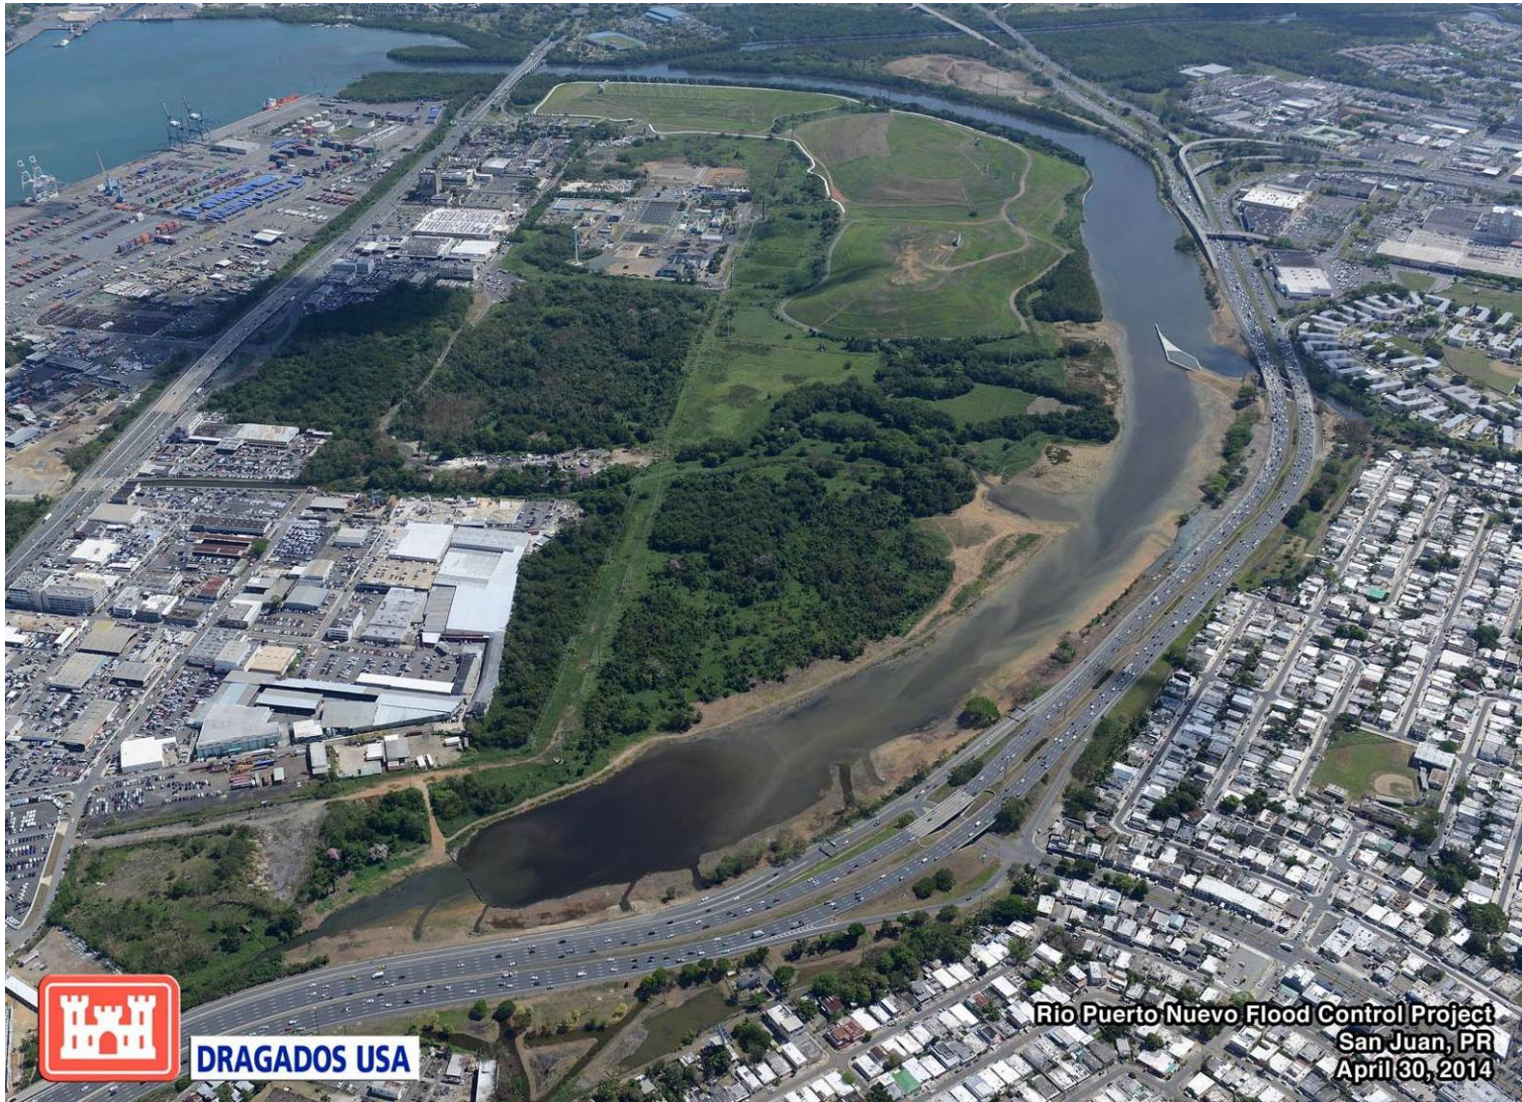
Figure 4. Aerial photo of finished project.

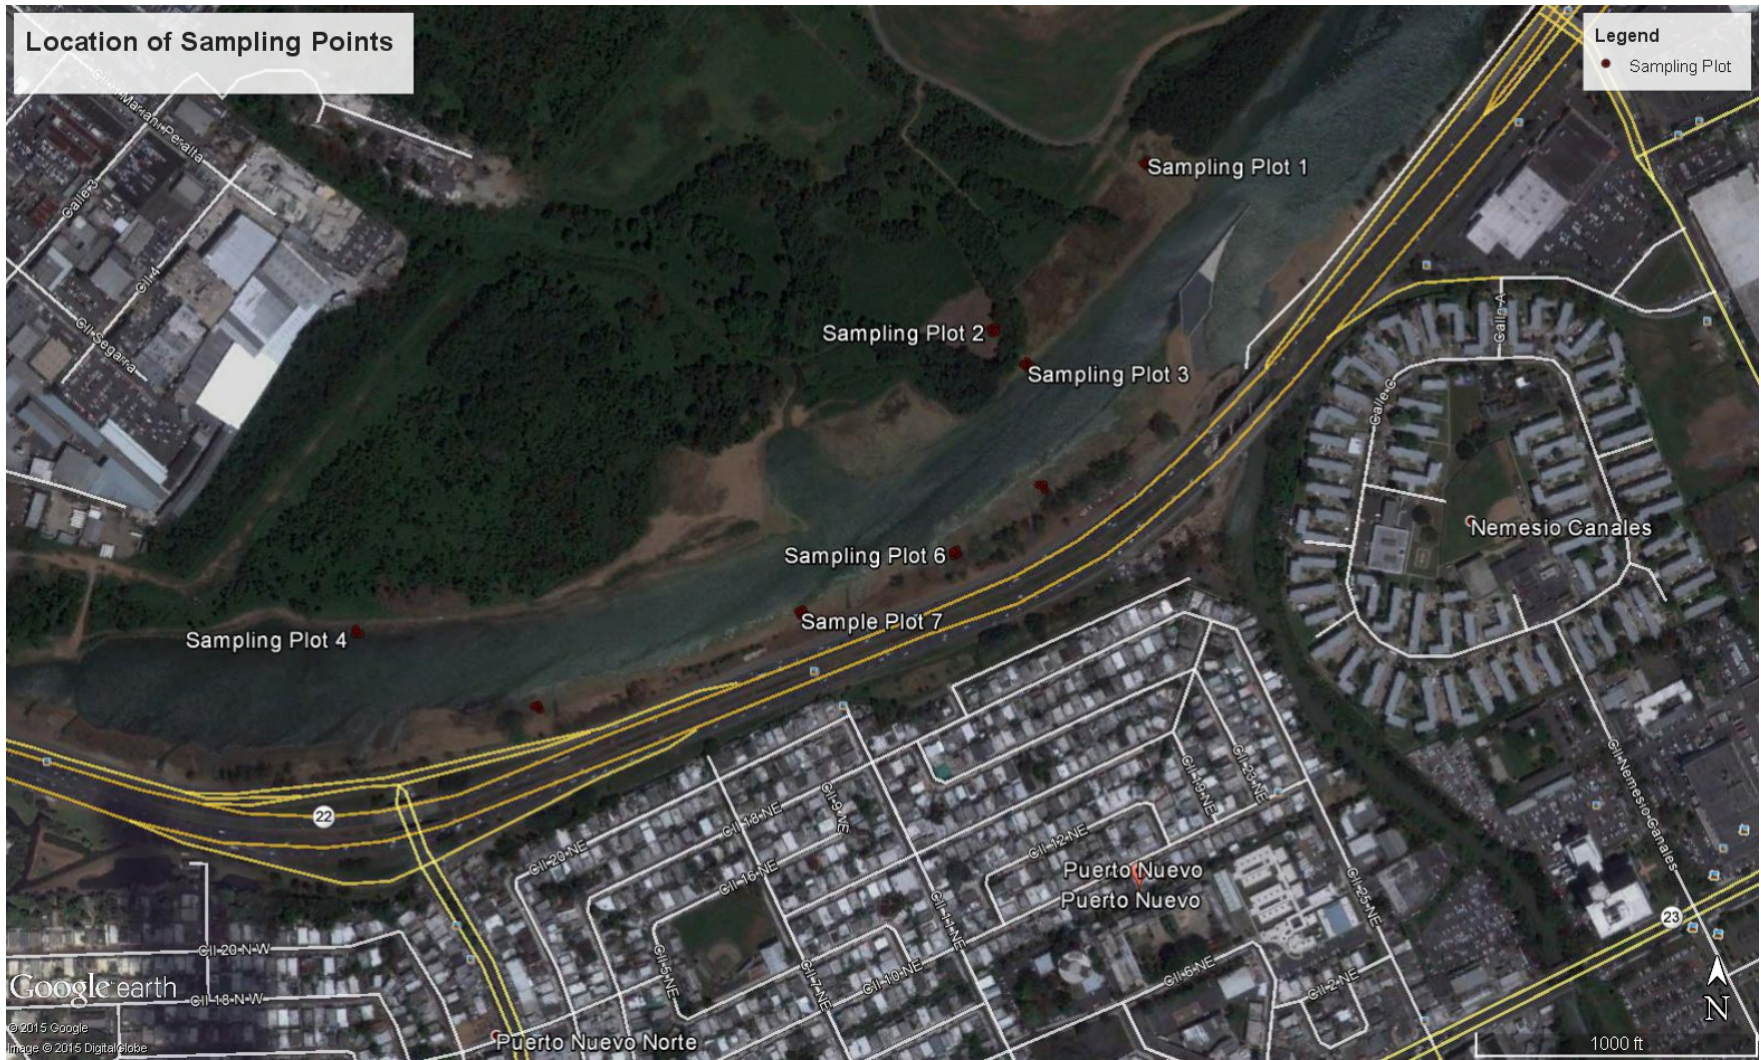
On April 16, 2015 the eight 5 x 5 m permanent monitoring plots were surveyed (see Figure 4 for plot location). The purpose of the monitoring plots is to document the establishment and cover of the planted species and the presence of any unwanted species.

Figure 5. Location of sampling plots.
